# Full-scale test of glazing for stairs in theatre

Alexander G. Chesnokov,  
Stanislav A. Chesnokov  
Glass Research Institute,  
Moscow, Russia

GPD Finland 2013  
14.06.2013

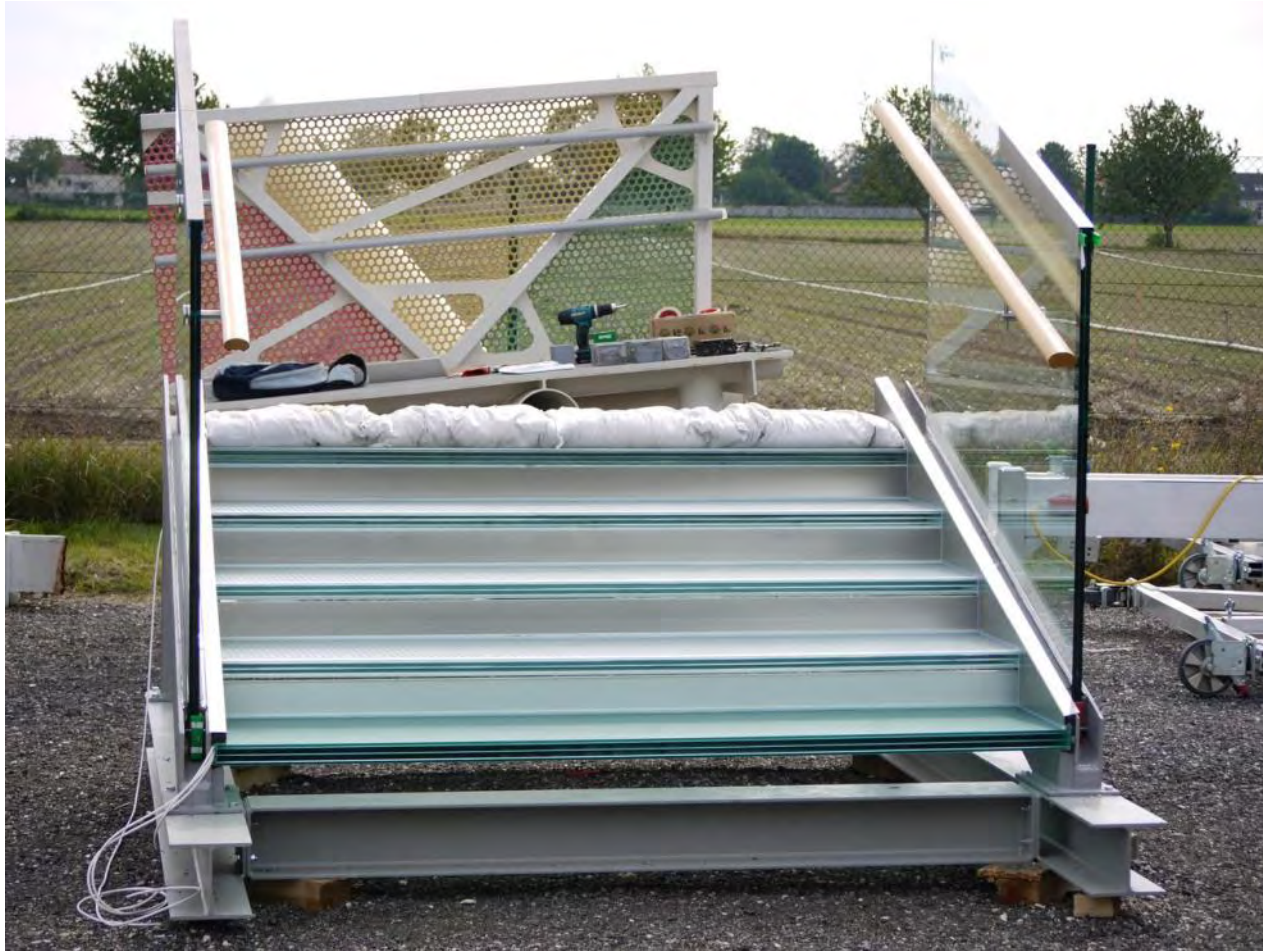
# The stair mock-up (day)

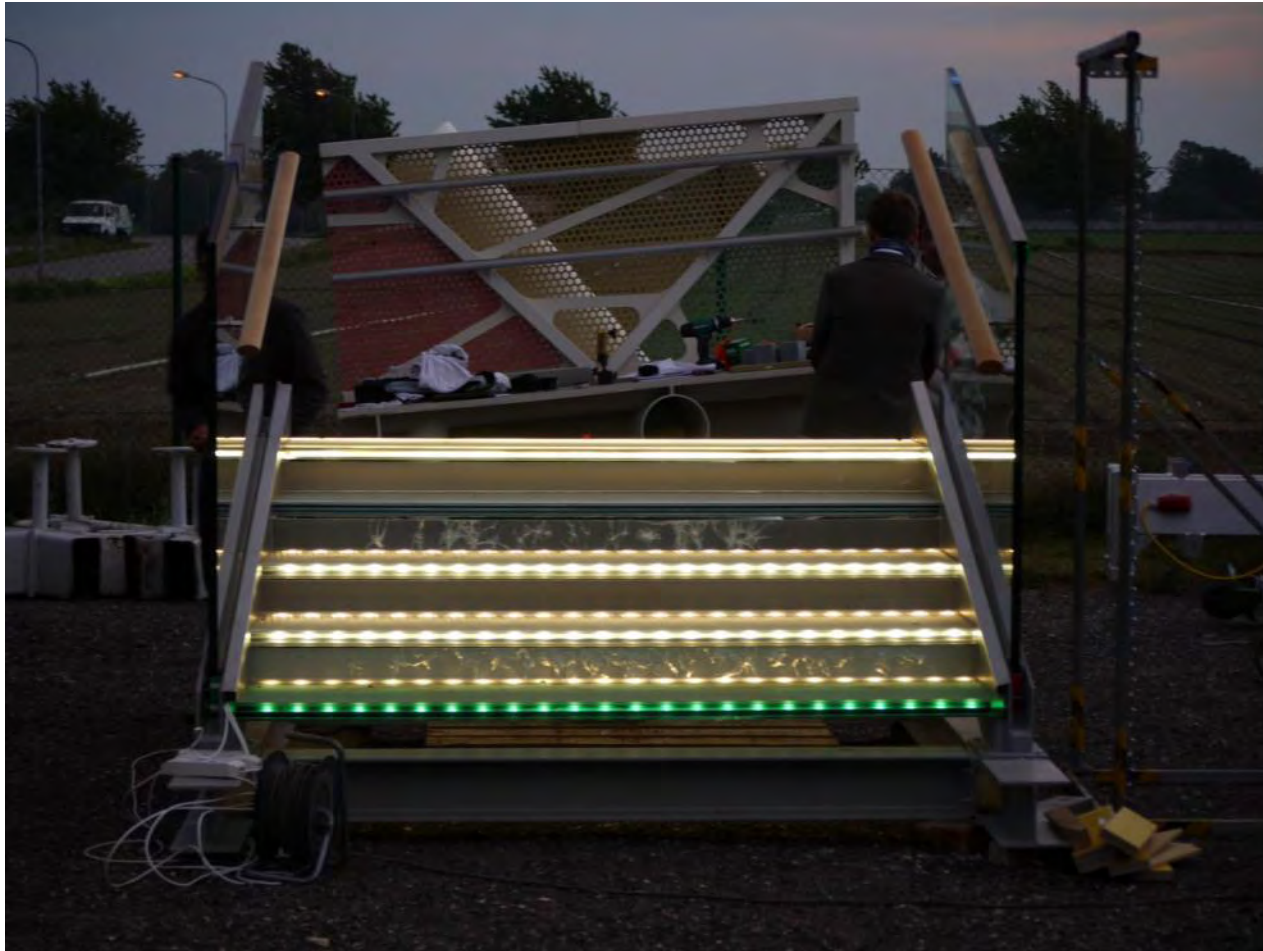
# The stair mock-up (night)

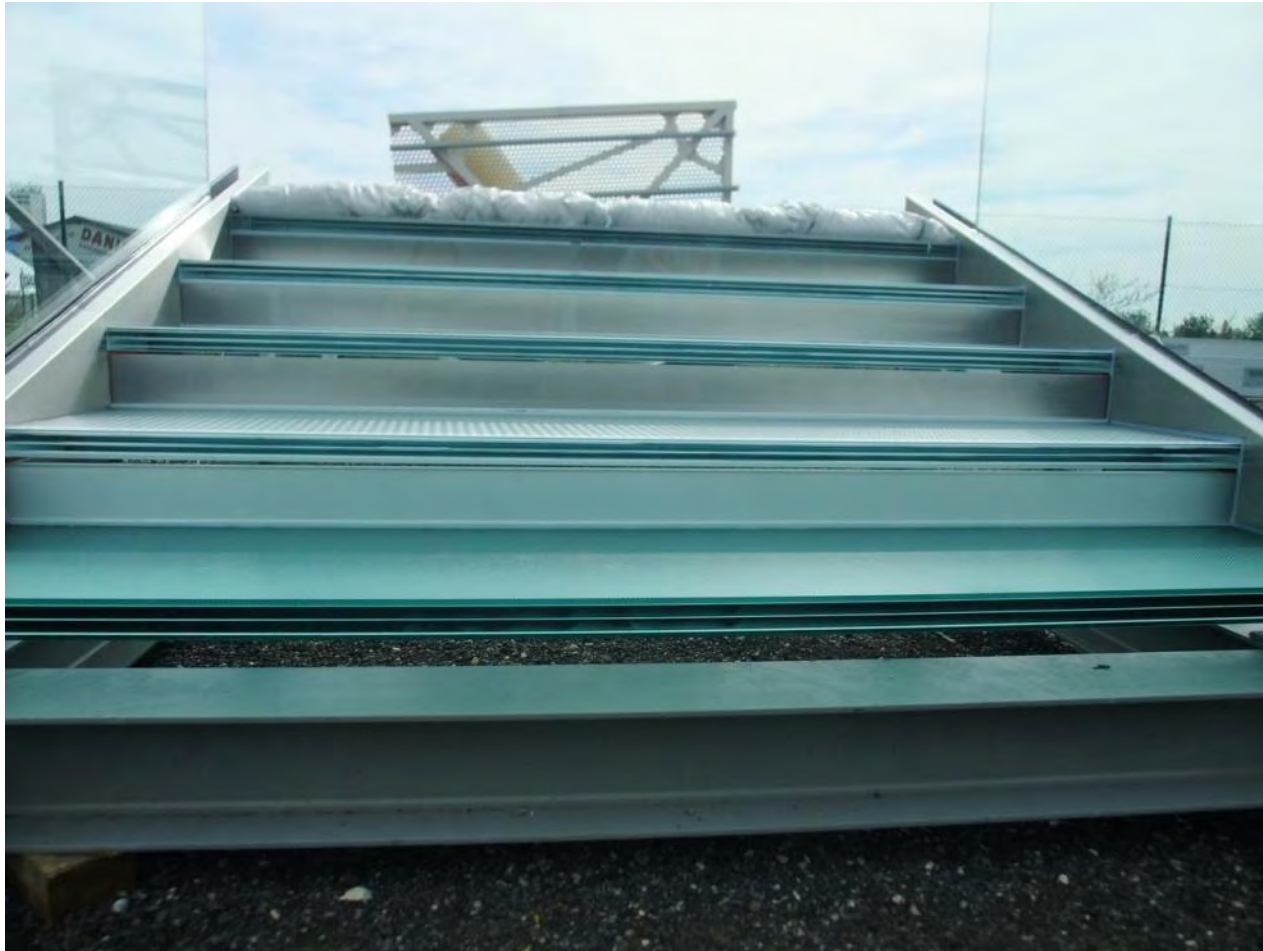
# The stair mock-up (details)

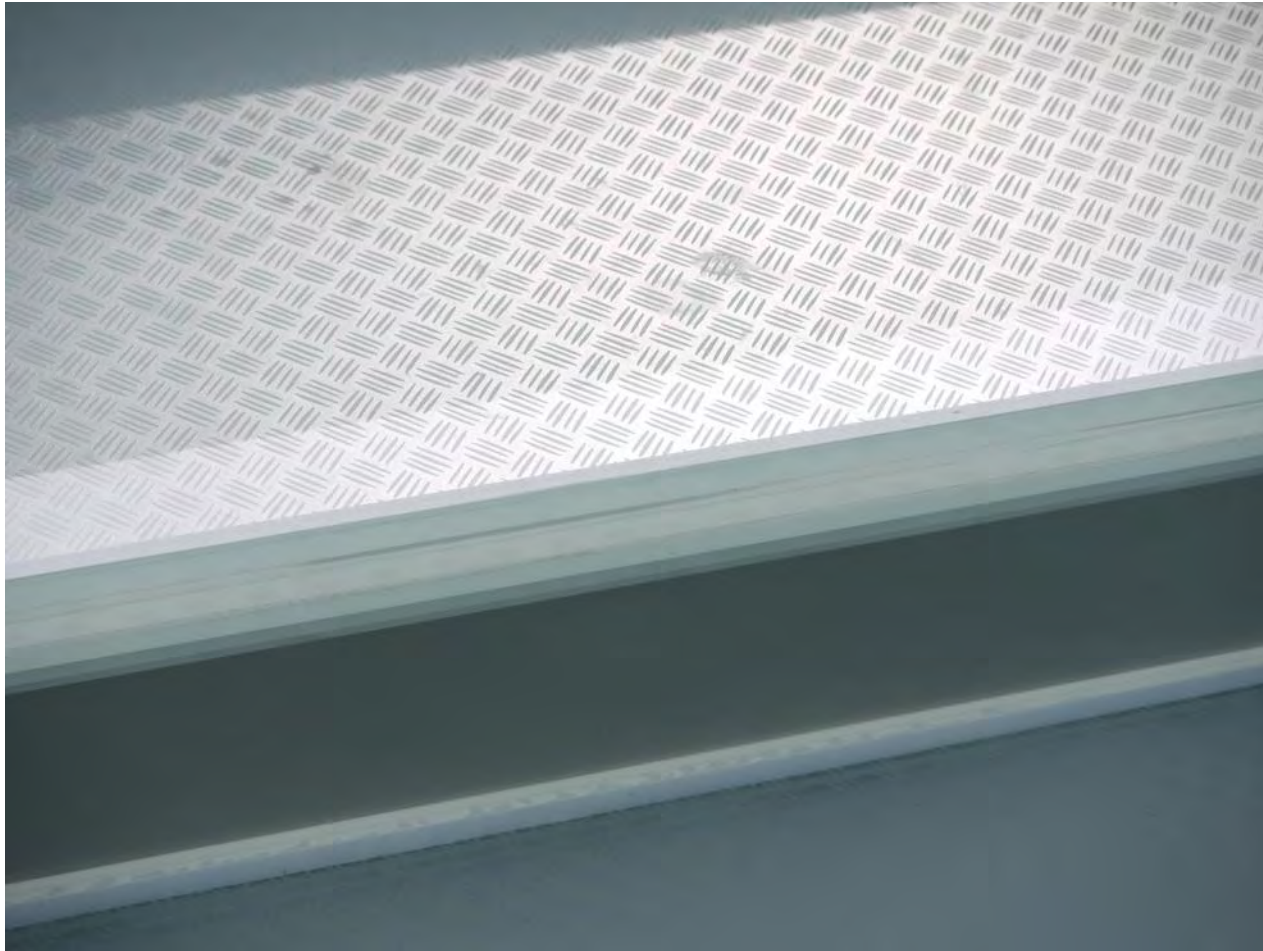
# The specimens: “Step 8hs.12hs.12hs.8hs”

- ▶ All specimens of “Step 8hs.12hs.12hs.8hs” showed good performance and passed all tests without serious comments.
  - Average deflection under concentrated load of 600 kg was 8.21 mm which very close to the recommended deflection of 8.00 mm (for uniform load).
- ▶ Ionoplast interlayers showed very good stability and stiffness comparing to PVB films.
- ▶ Specimens of “Step 8.15.15.8” did not pass the tests.
  - Average deflection under uniformly distributed load was lower than recommended deflection: 6.40 mm comparing to 6.80 mm.
- ▶ All specimens of “Barrier 12t.12t” passed their tests very successfully.

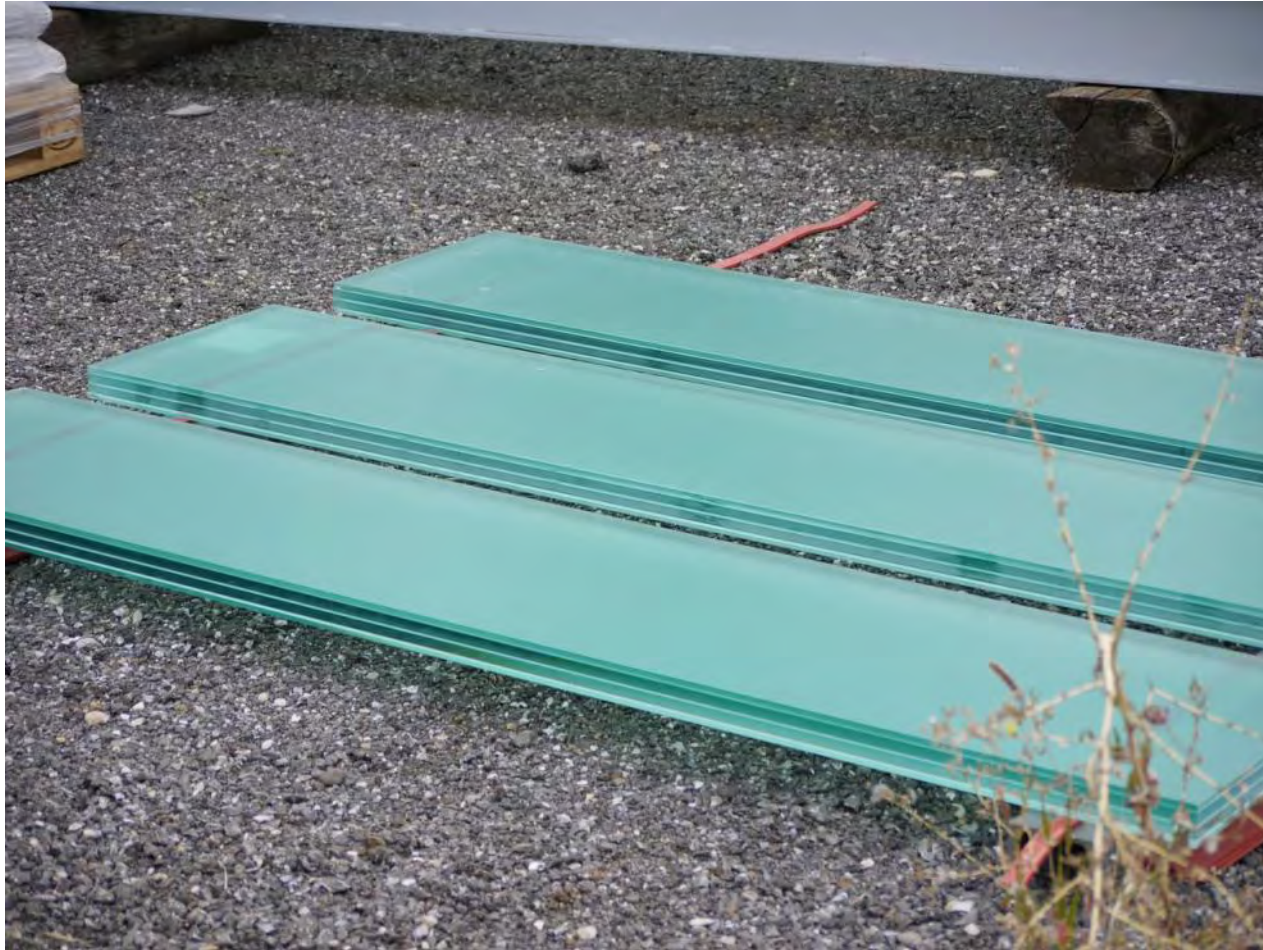
# The specimens: “Step 8.15.15.8” (2000×400 mm)

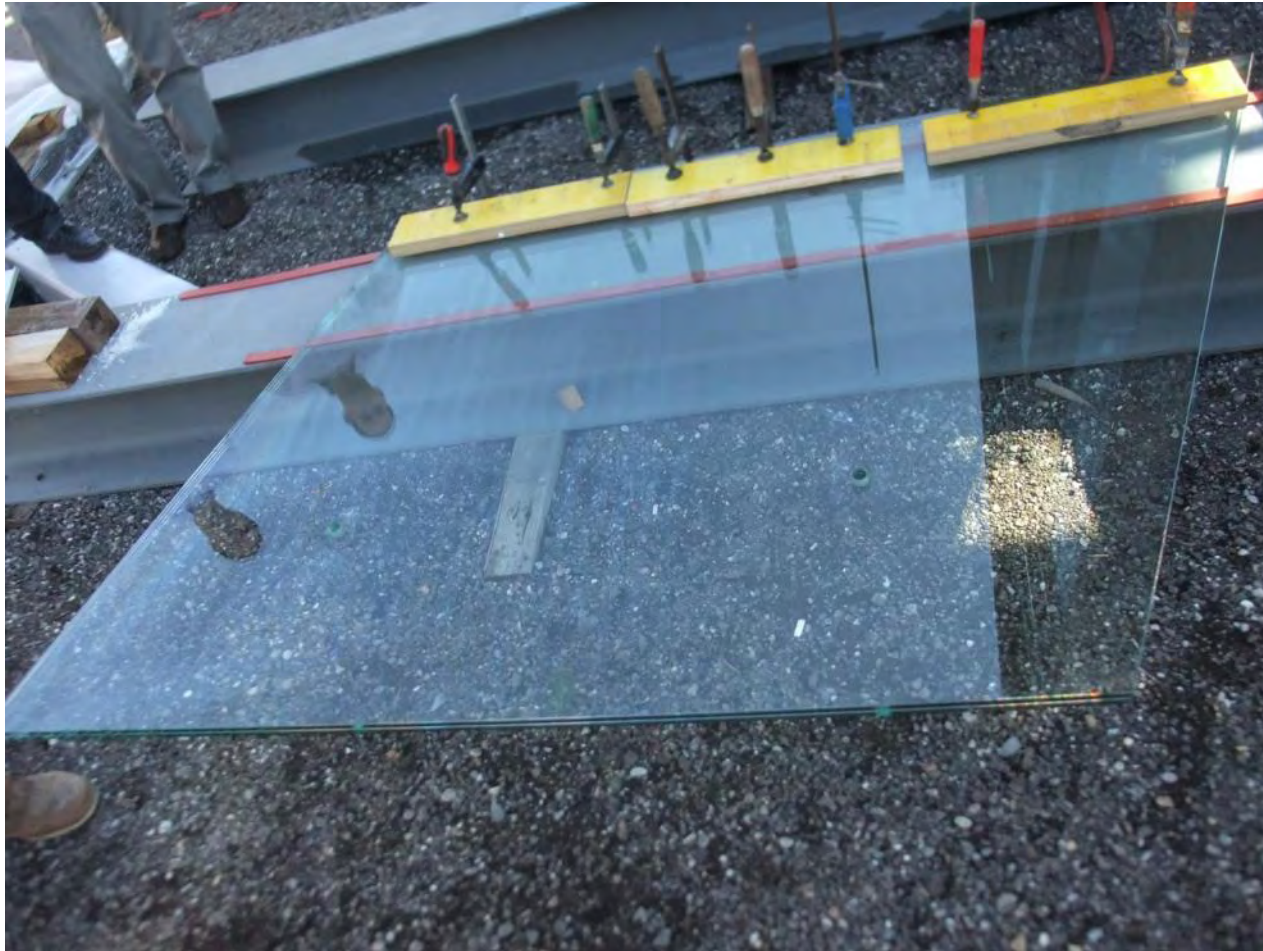
# The specimens: “Barrier 12t.12t”

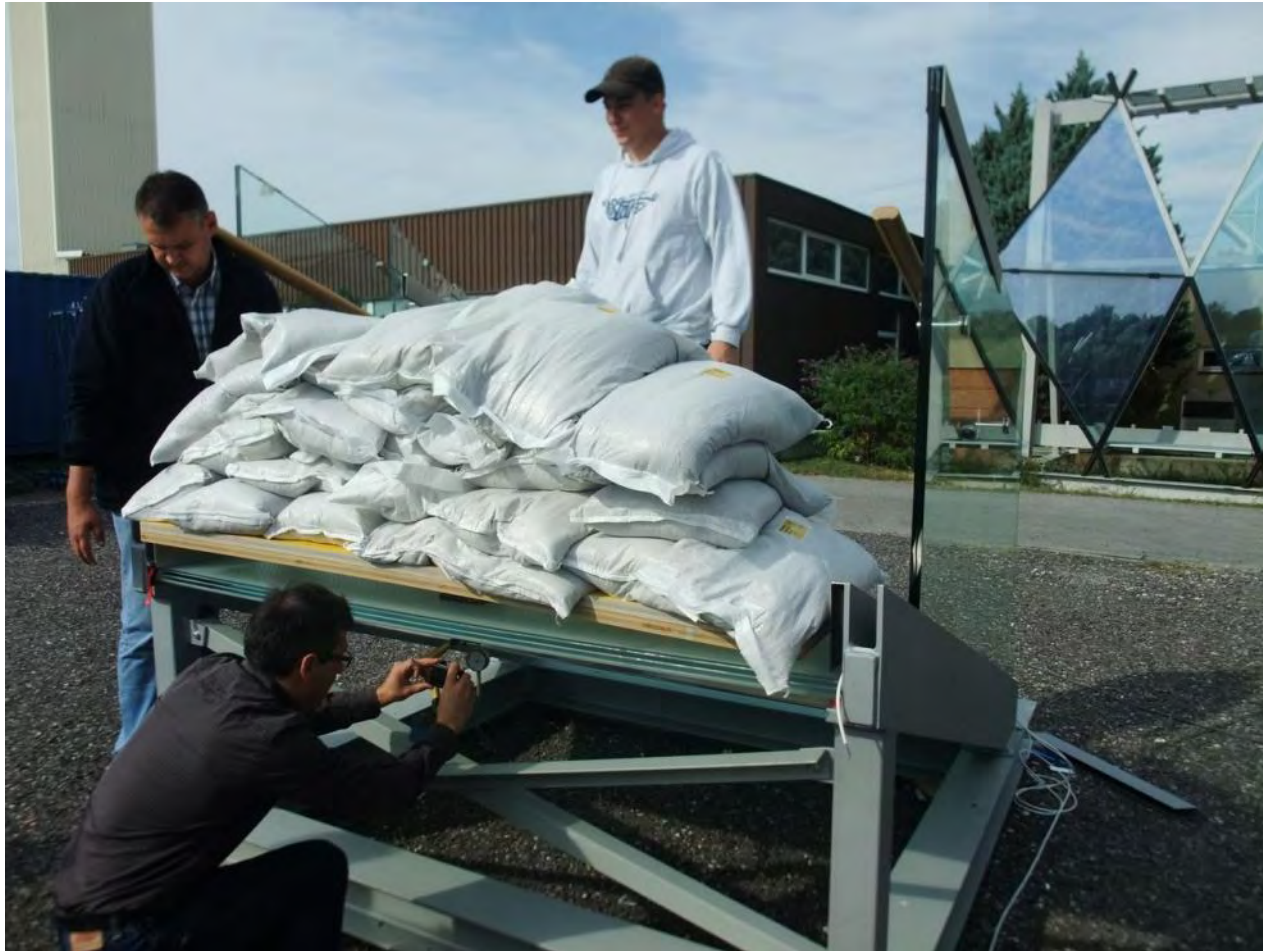
# The tests and results

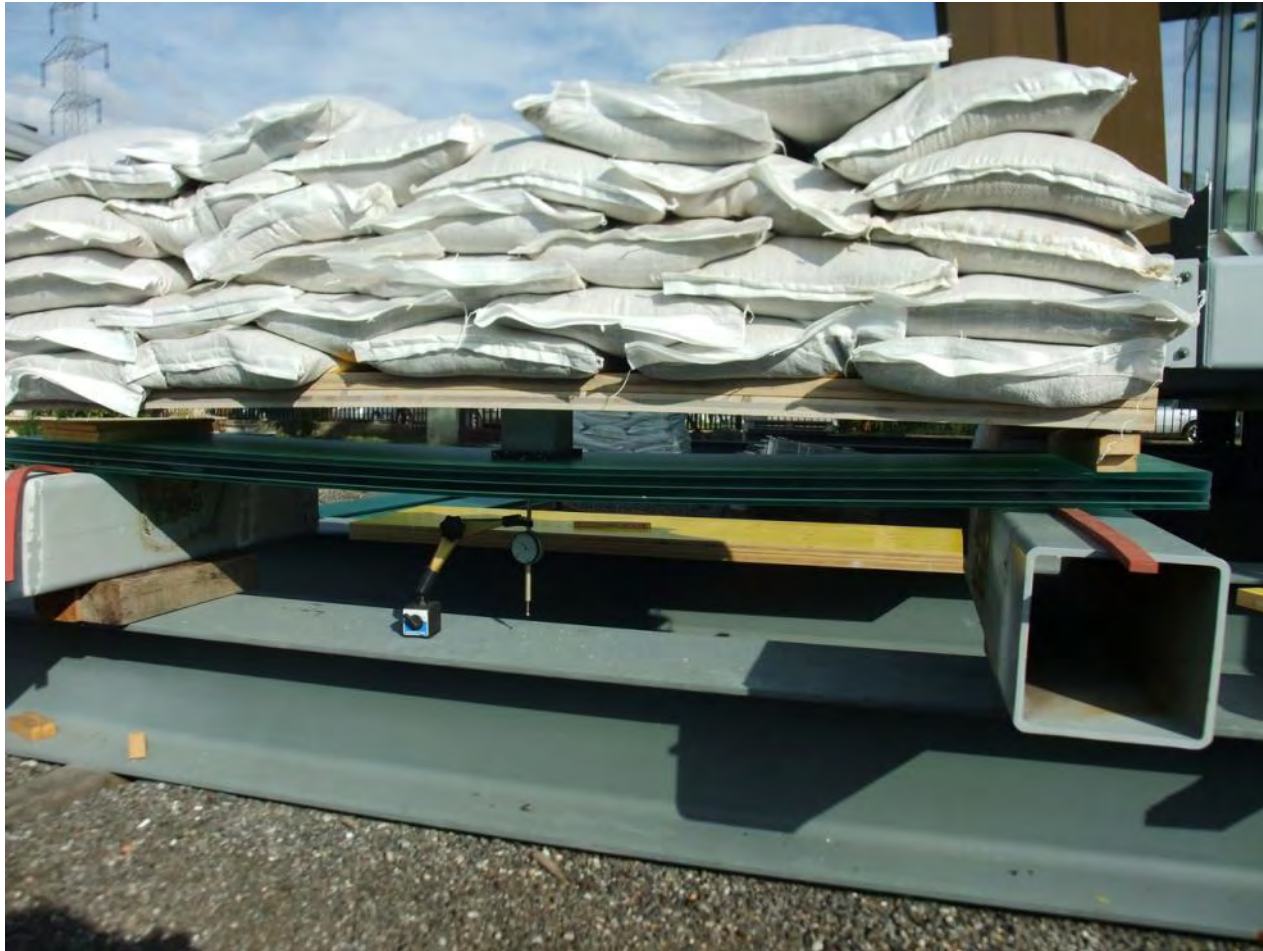
# Concentrated load test (1700 mm gap)

- 6 kN was applied in the center of the specimen through the square nylon gasket and 100 mm side steel cube.
- ▶ **Shock load by steel ball (EN356):**

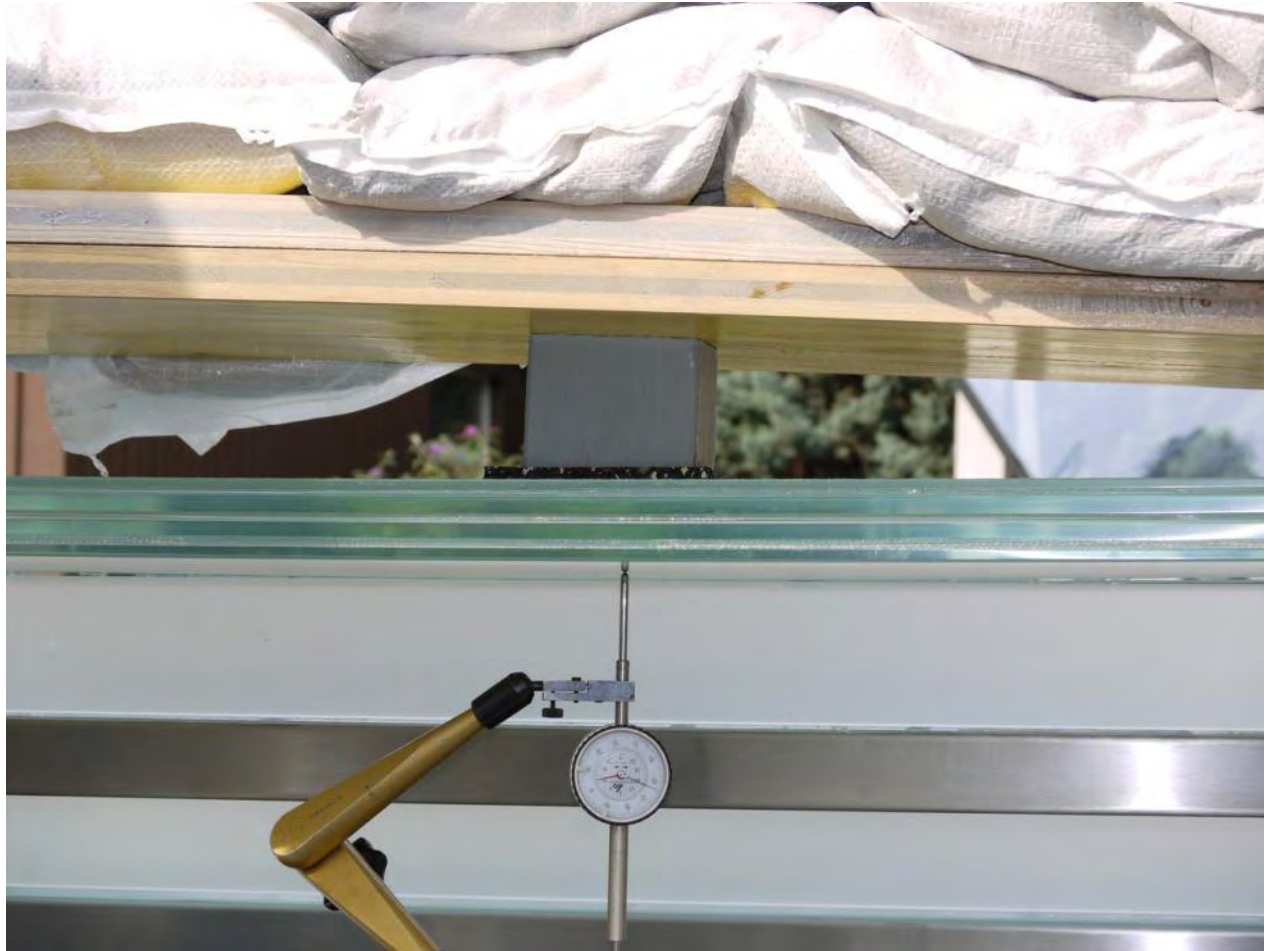
# Static load test results (Step 8hs.12hs.12hs.8hs #1)

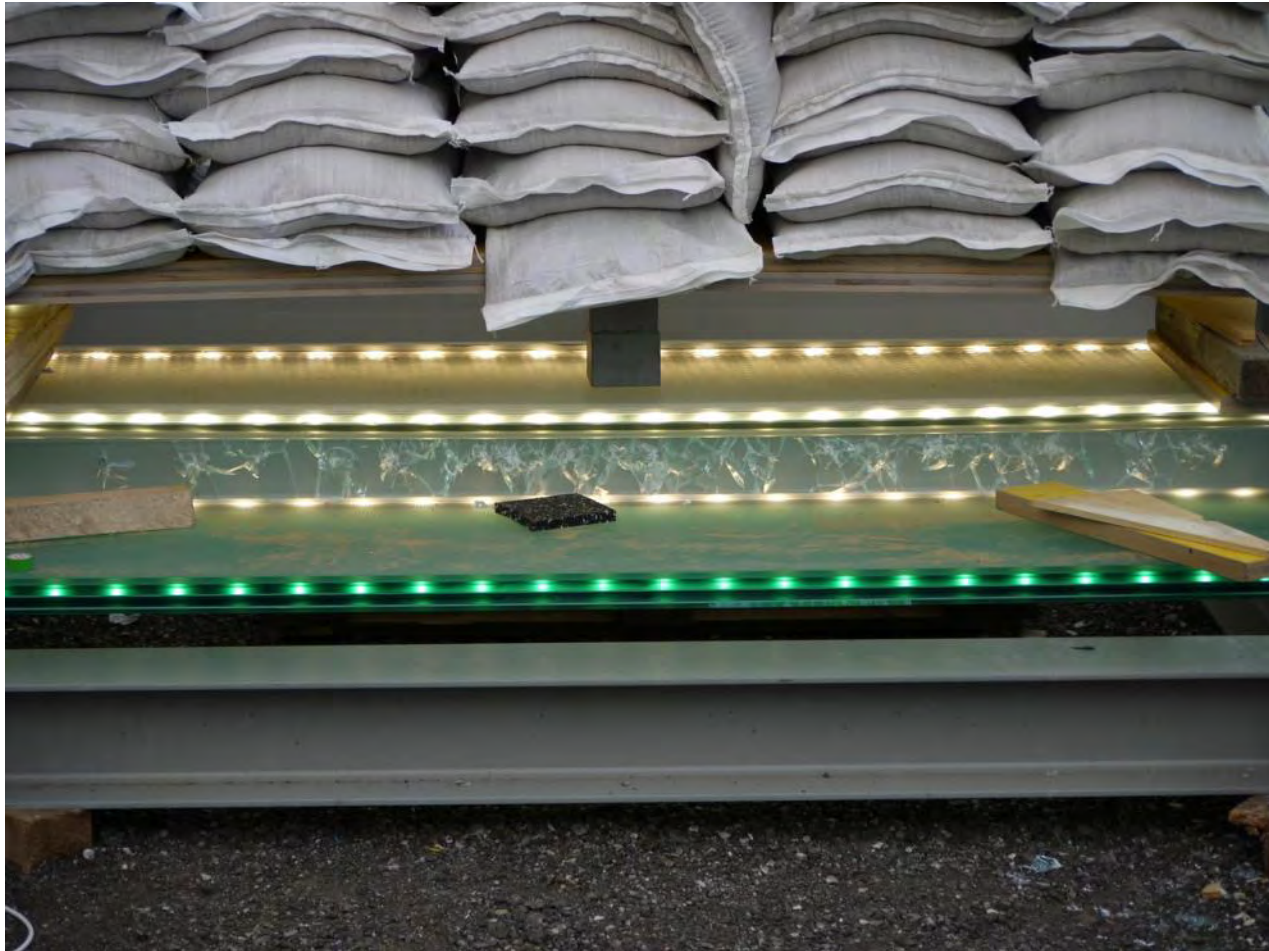
# Static load test results (Step 8hs.12hs.12hs.8hs #3)

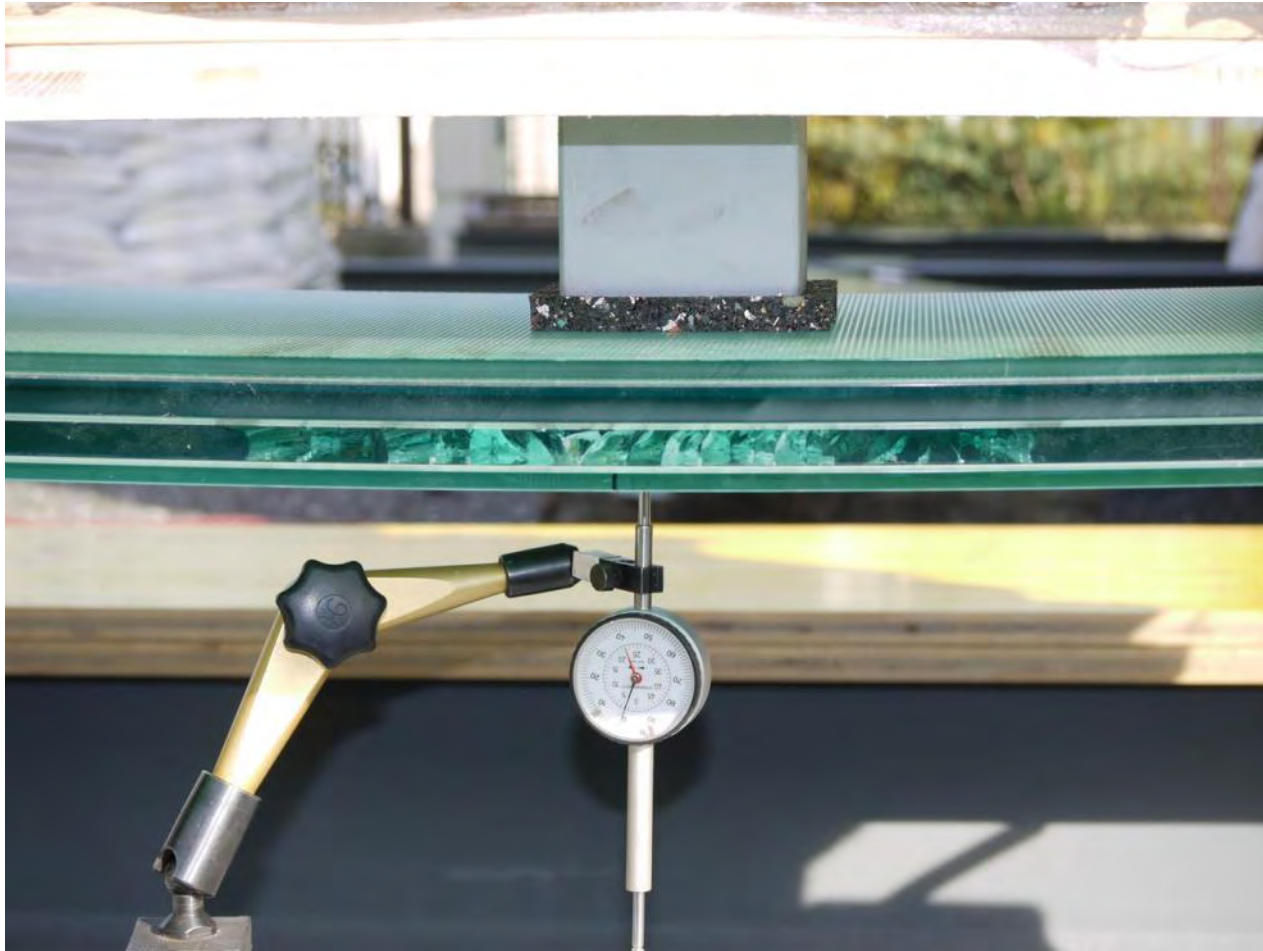
# Concentrated load test results (Step 8.15.15.8 #1) (1 / 3)

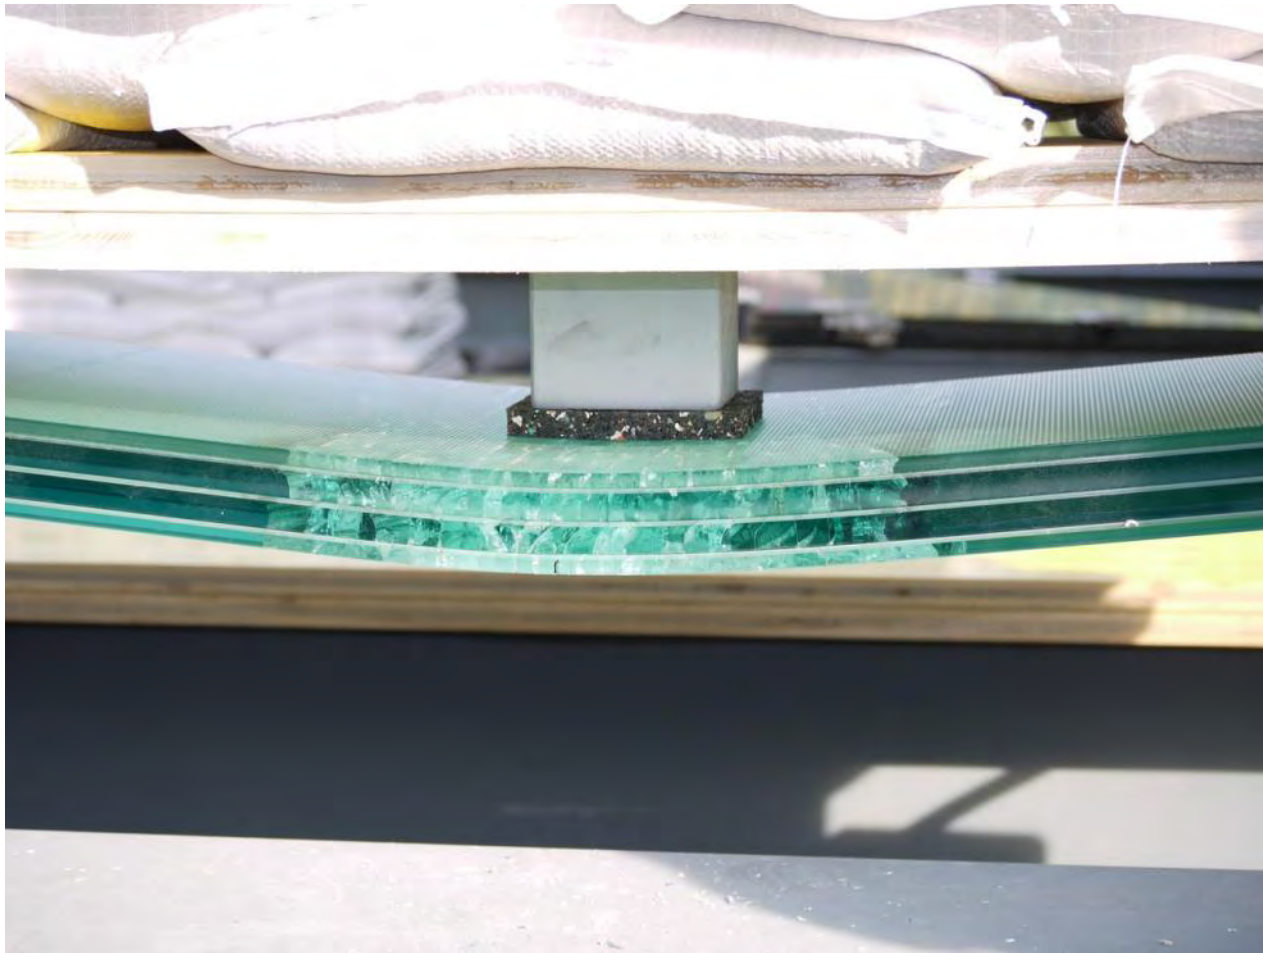
# Concentrated load test results (Step 8.15.15.8 #1) (2 / 3)

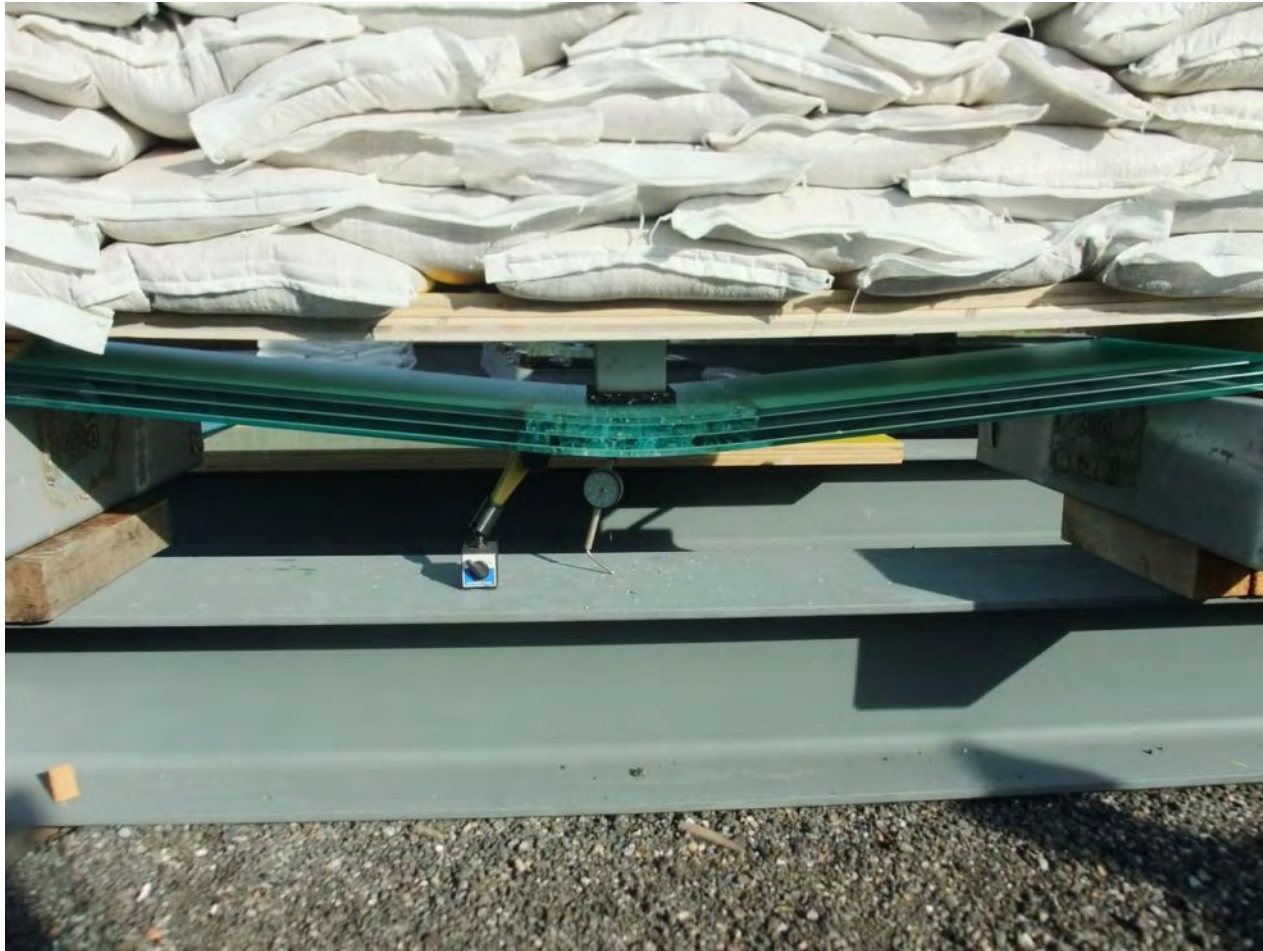
# Concentrated load test results (Step 8.15.15.8 #1) (3 / 3)

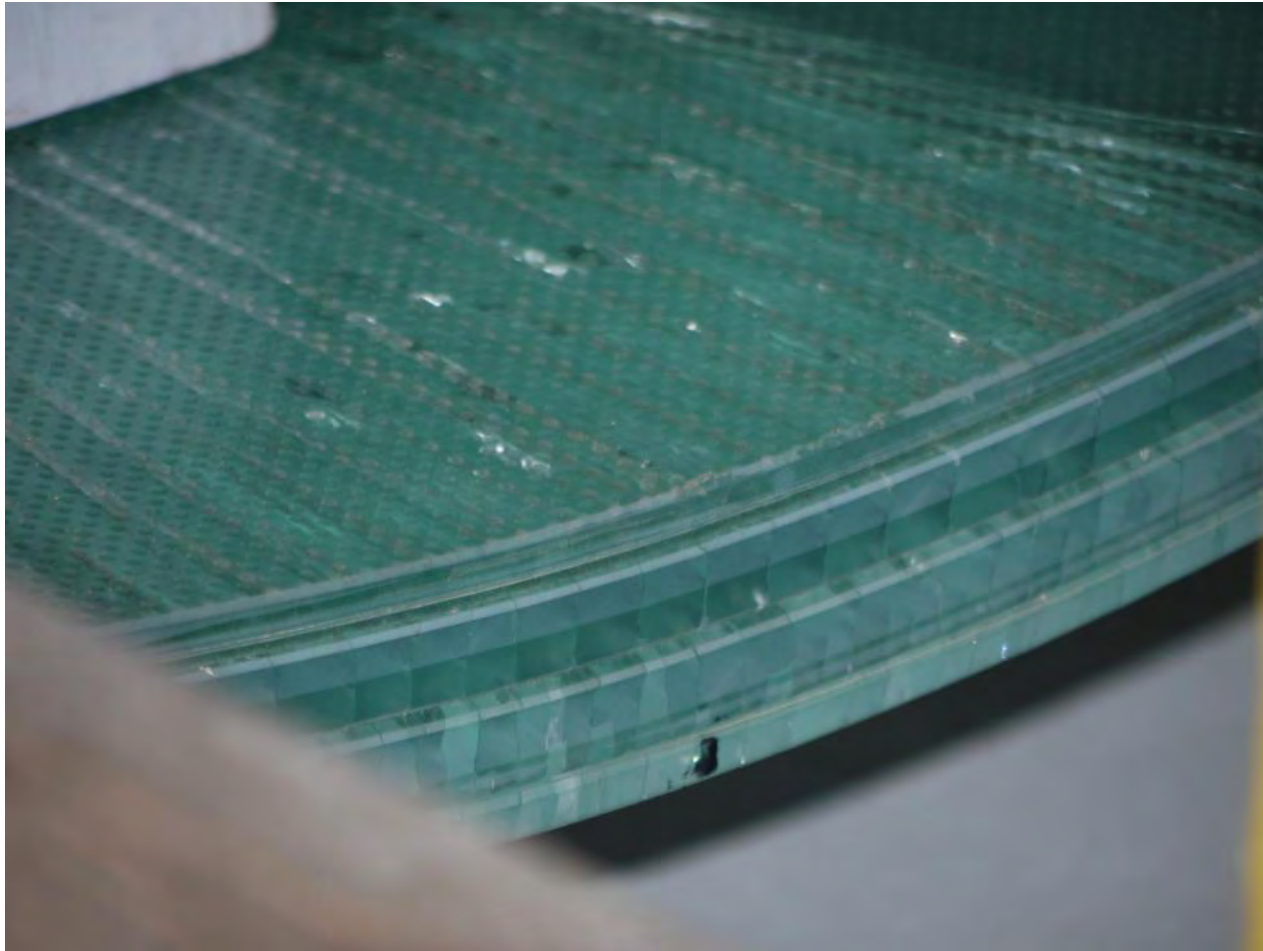
# Concentrated load test results (Step 8.15.15.8 #3)

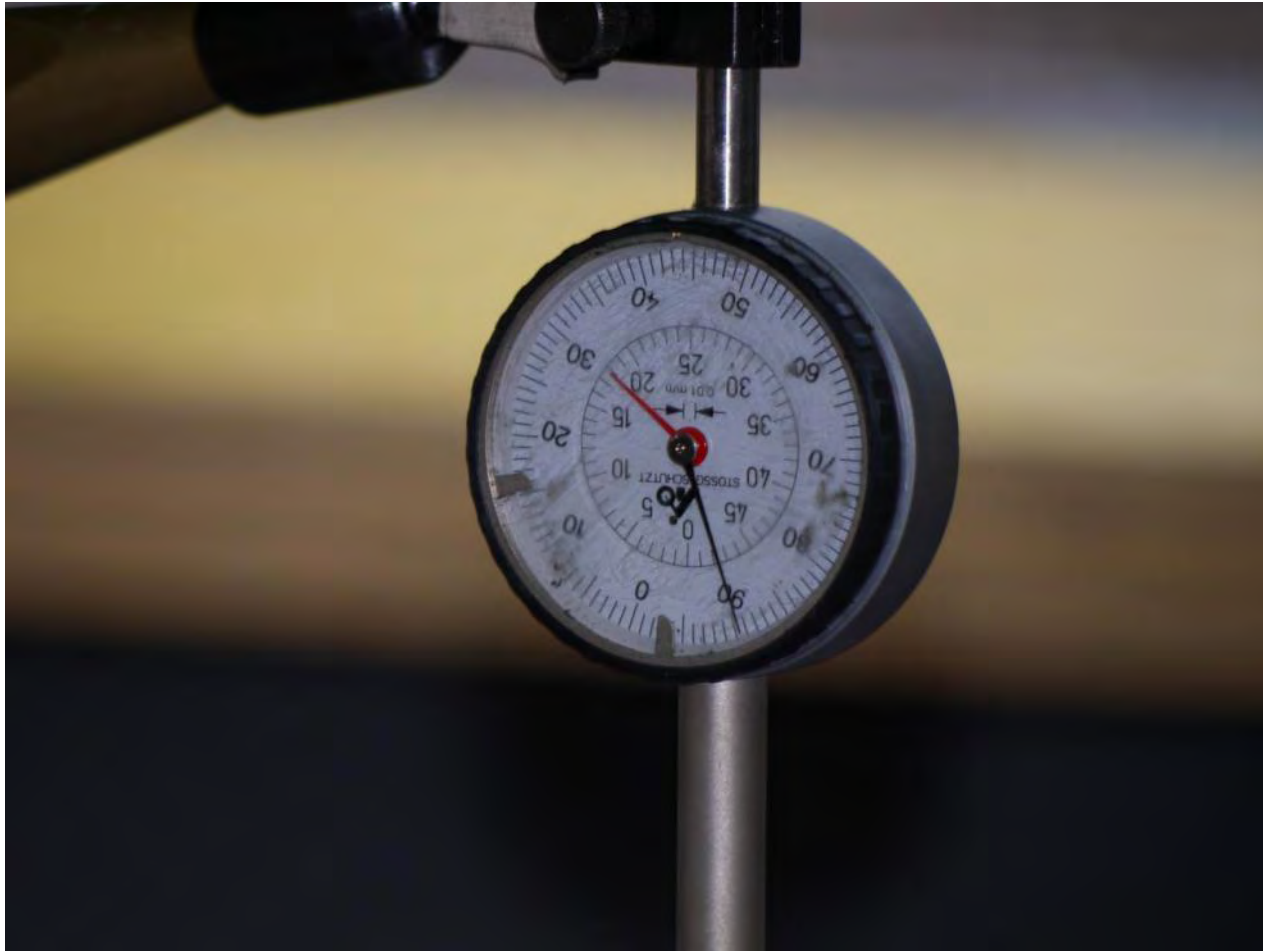
# Concentrated load test results (Step 8.15.15.8 #2)

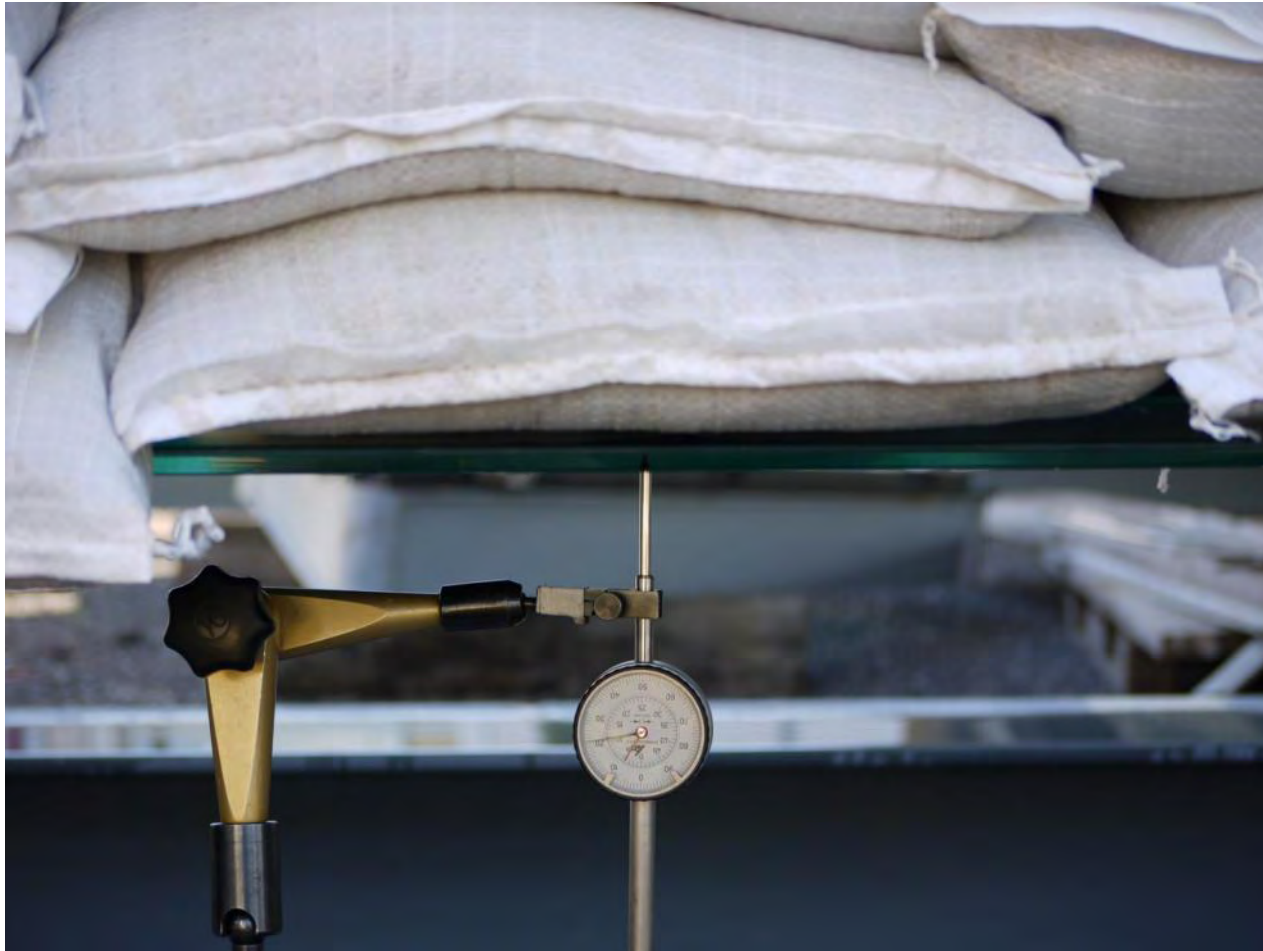
# Uniform load test results (Step 8.15.15.8 #5)

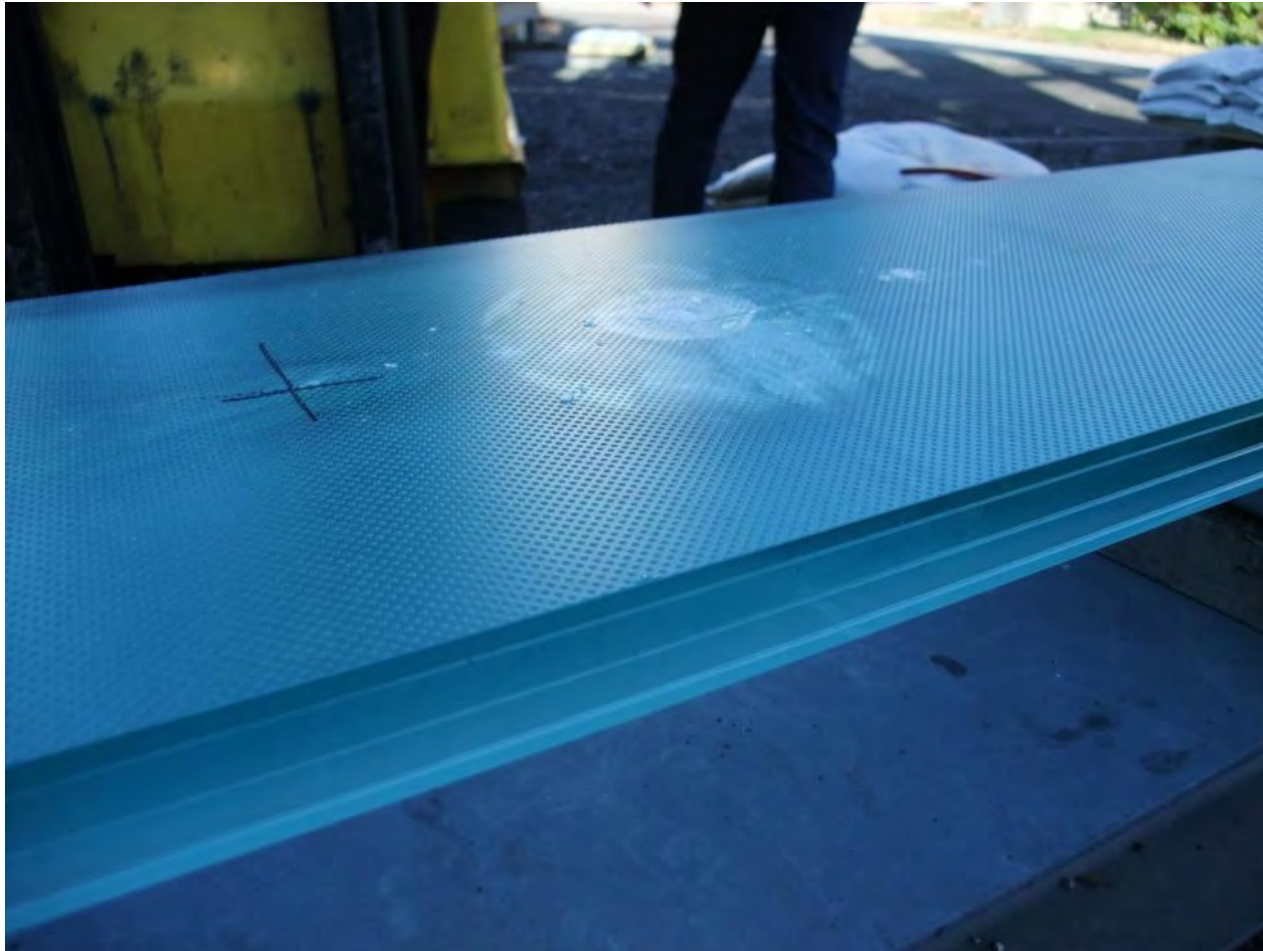
# Hard body impact test results (Step 8.15.15.8 #2) (1 / 2)

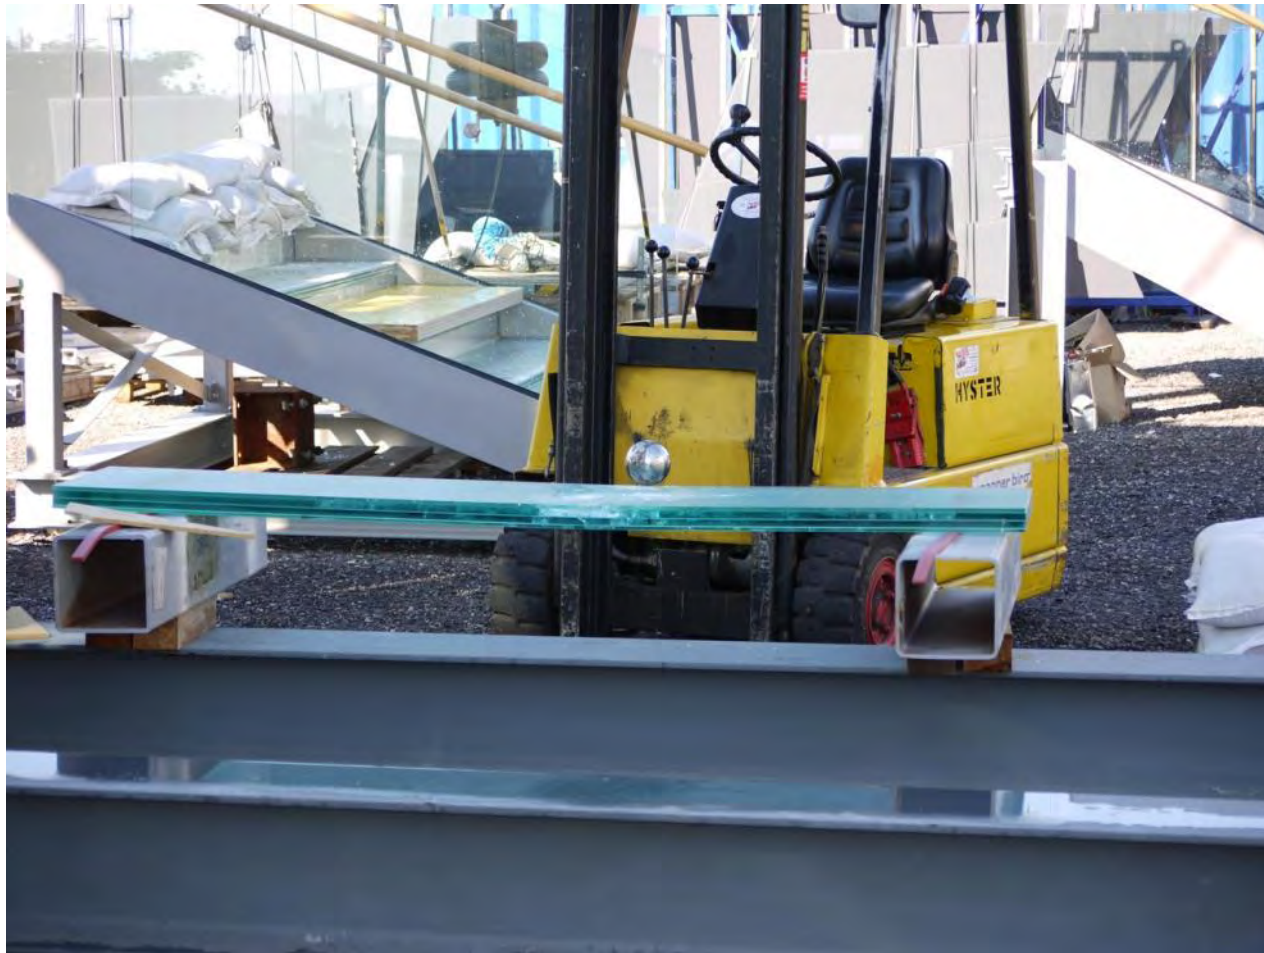
# Hard body impact test results (Step 8.15.15.8 #2) (2/2)

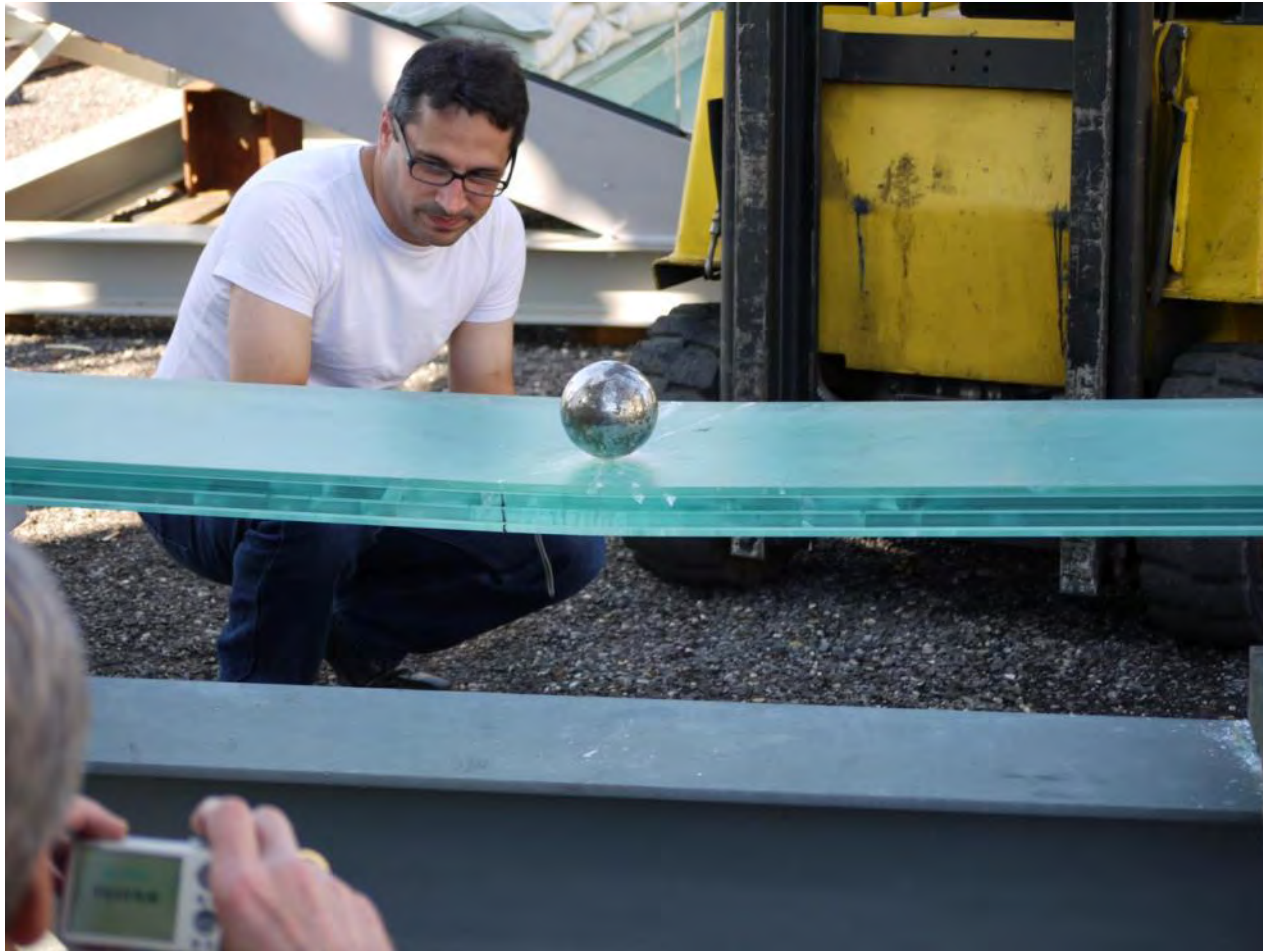
# Hard body impact test results (Step 8.15.15.8 #5)
