# Full-scale test of glazing for stairs in theatre

Alexander G. Chesnokov,  
Stanislav A. Chesnokov  
Glass Research Institute,  
Moscow, Russia

GPD Finland 2013  
14.06.2013

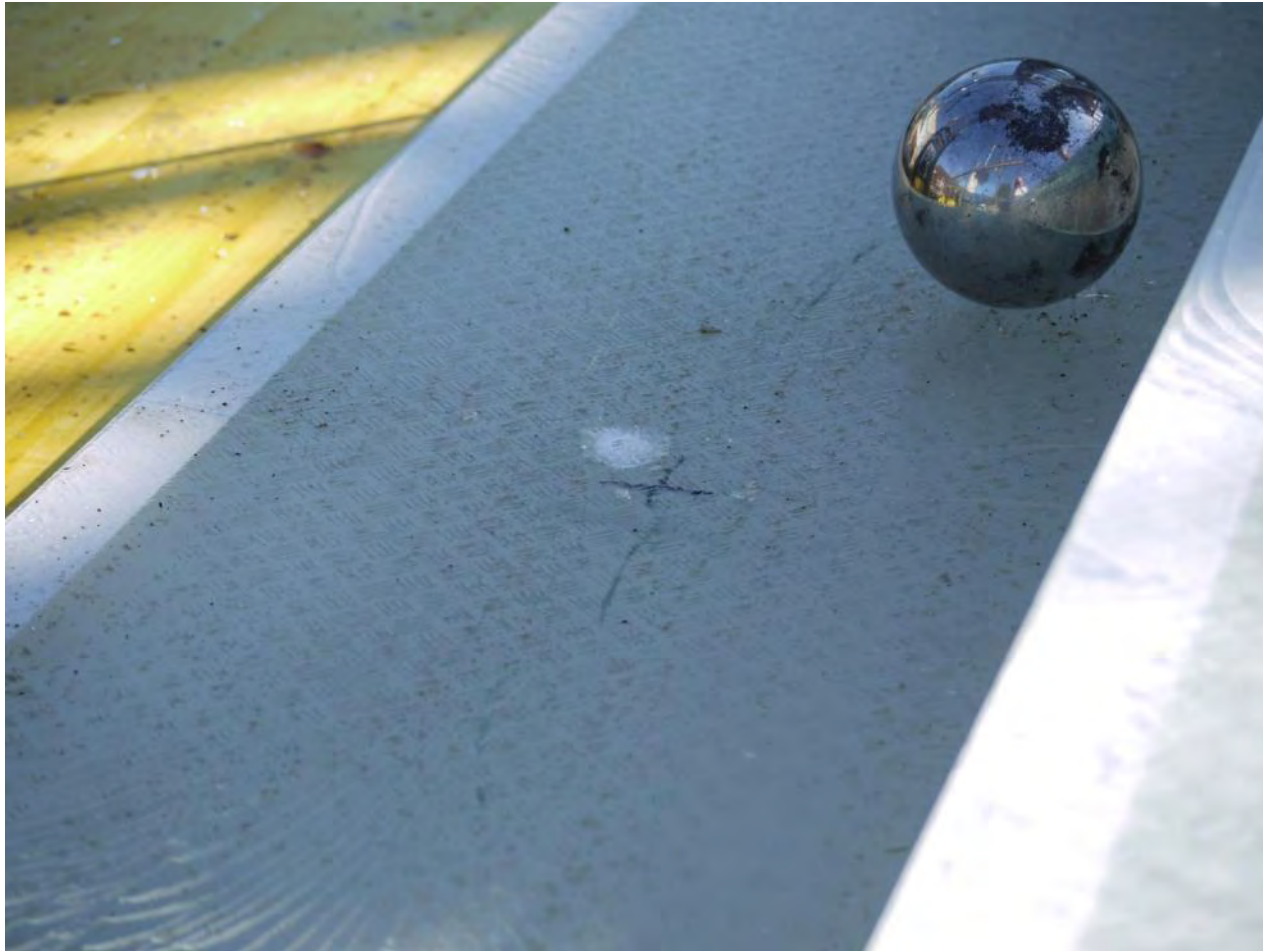
# Ball test results (Step 8hs.12hs.12hs.8hs #2) (1 / 2)

- Steel ball test with standard ball of 4.11 kg mass. Drop height: 3 meters (120 Joules).
    - a) Test started with first drop from 3 m height.
    - b) Upper layer of glass must be broken after that by hand if it was not broken by ball. After that, second and third drops were carried out.

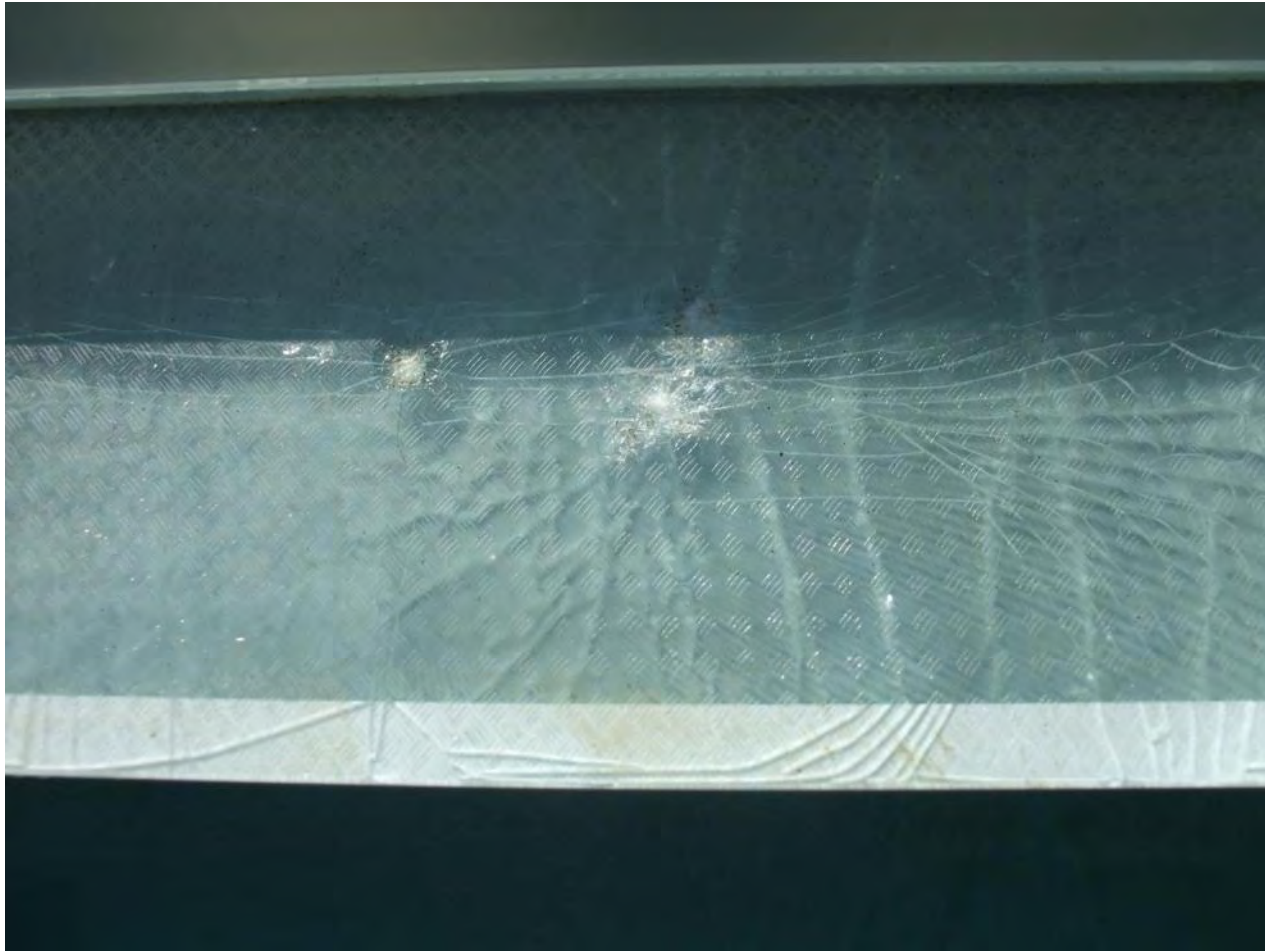
# Ball test results (Step 8hs.12hs.12hs.8hs #2) (2 / 2)

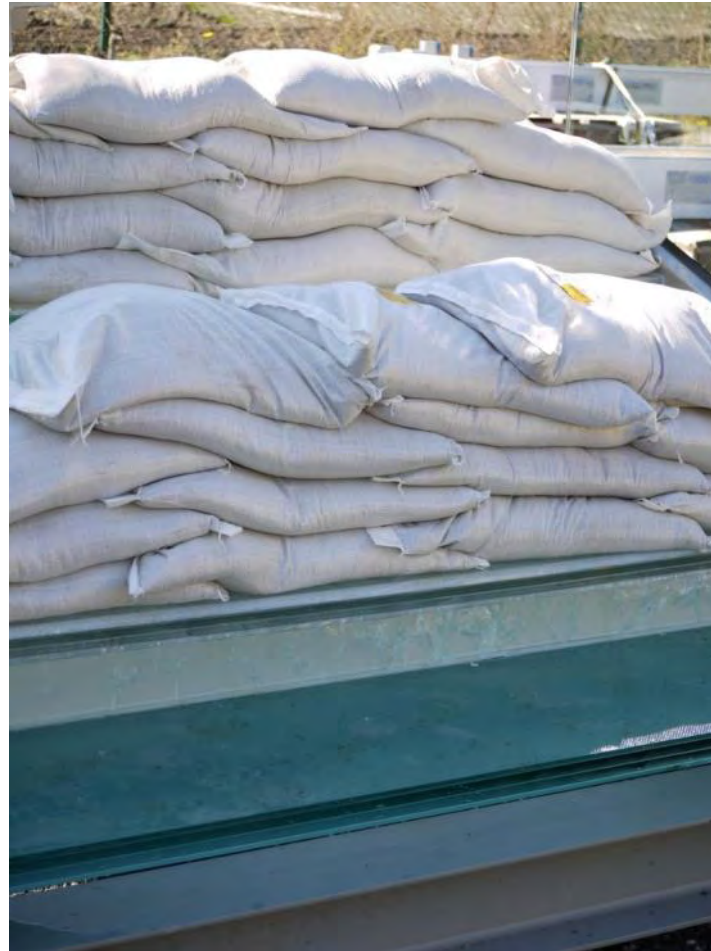
# Hard body impact test results (Step 8hs.12hs.12hs.8hs #3)

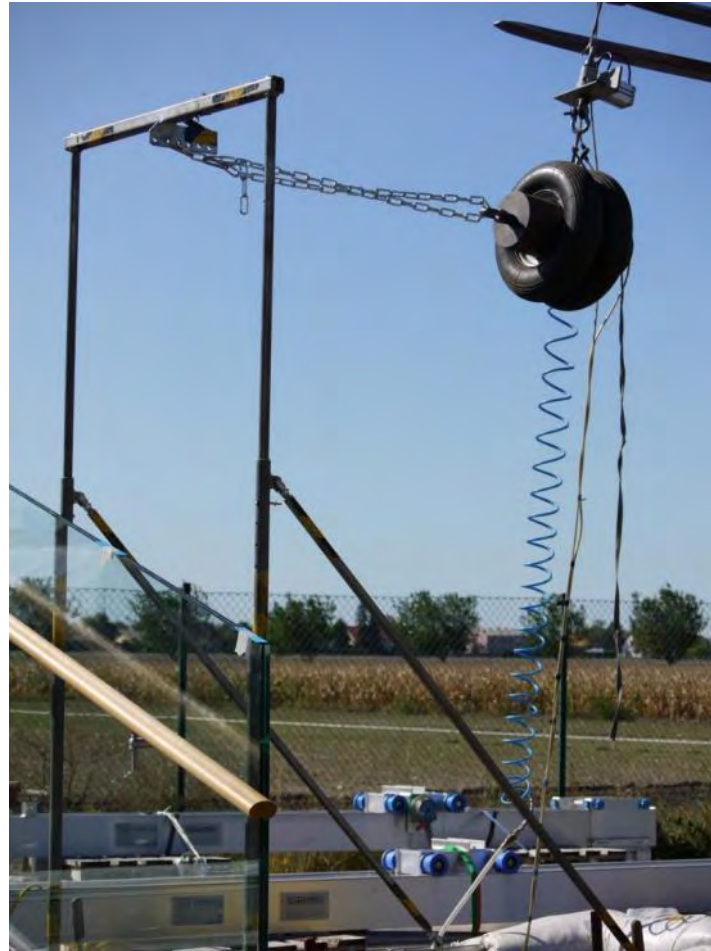
# Soft body impact test results (1 / 4)

- ▶ **Shock load by soft body impact:**
  - This is standard soft body impact test with rubber tires on metal core impactor. Soft body had mass of 50 kg and drop height was 1200 mm, so impact energy was 600 Joules. Detailed sequence was the following:

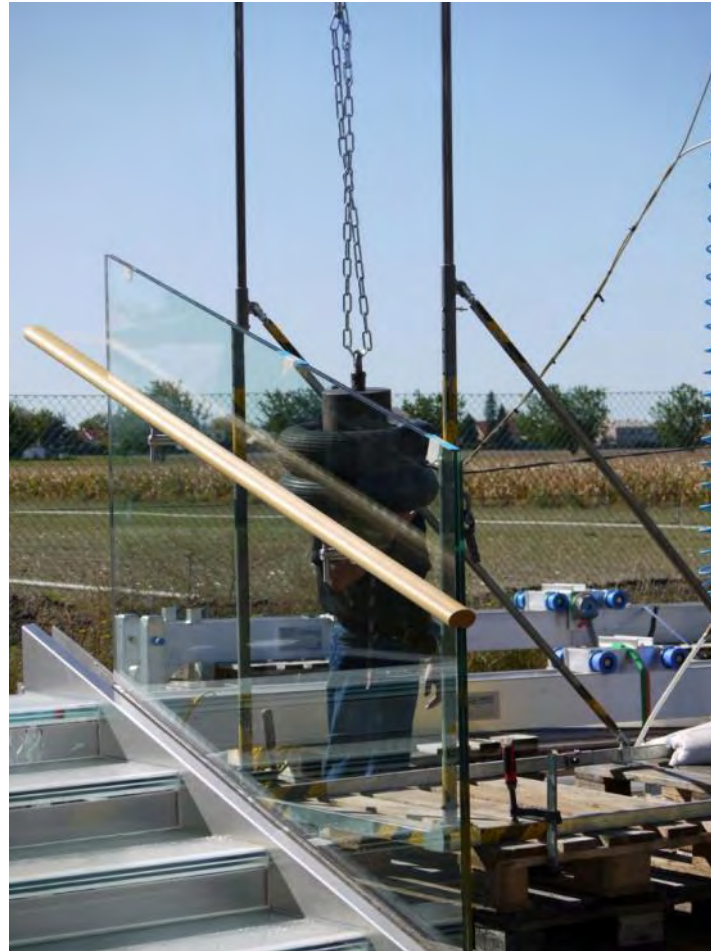
# Soft body impact test results (2/4)

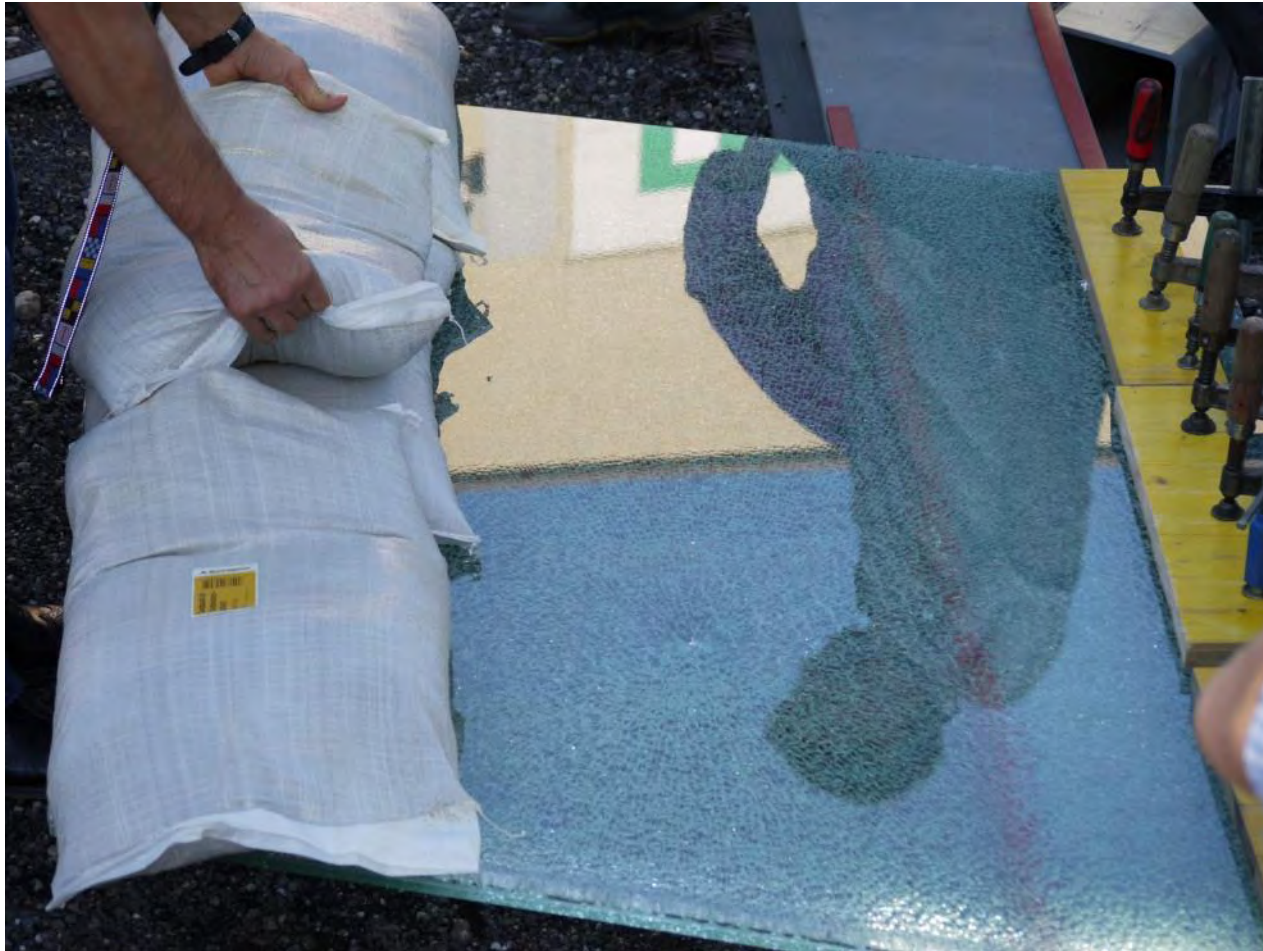
# Soft body impact test results (3 / 4)

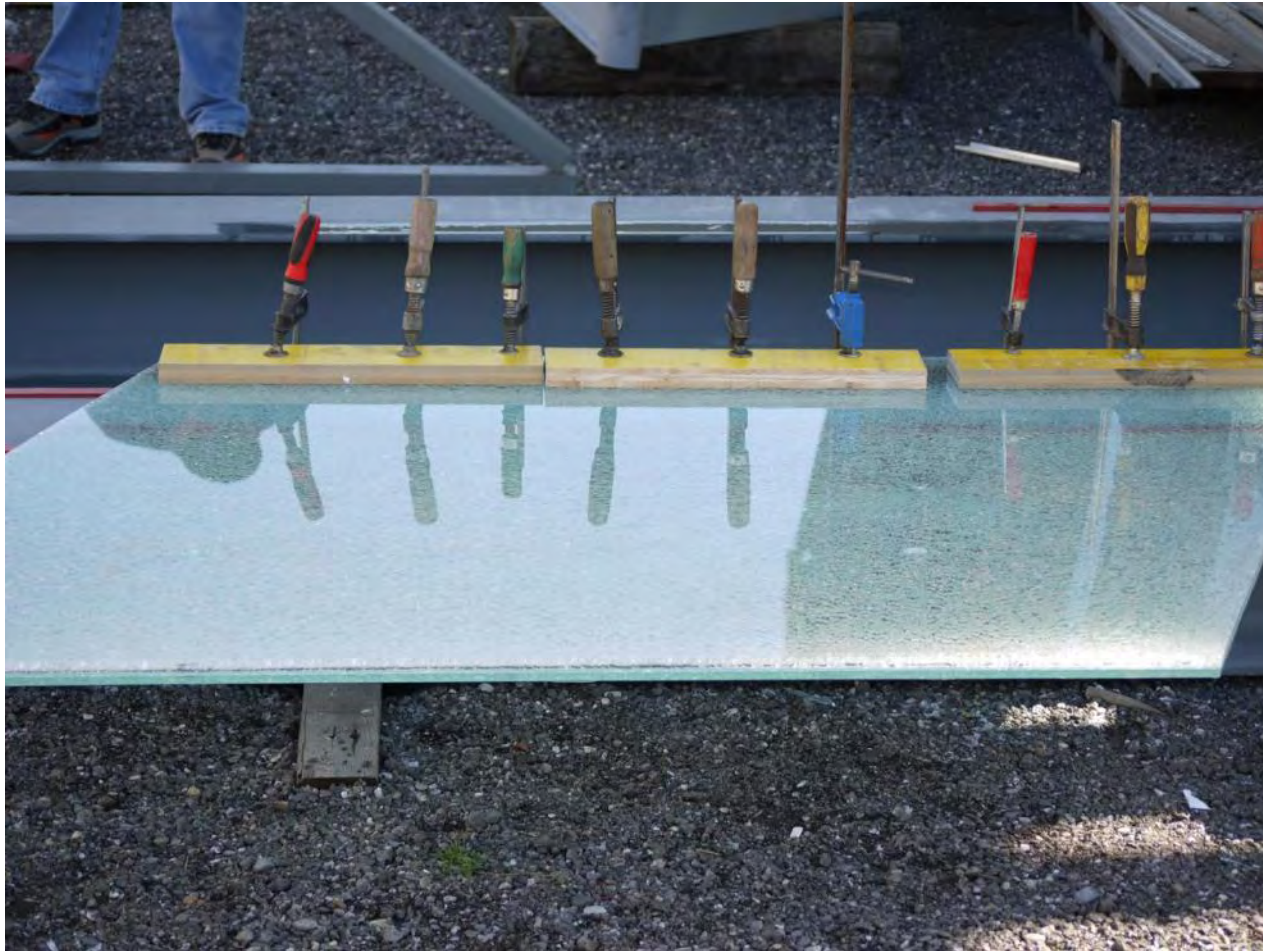
# Soft body impact test results (4 / 4)
